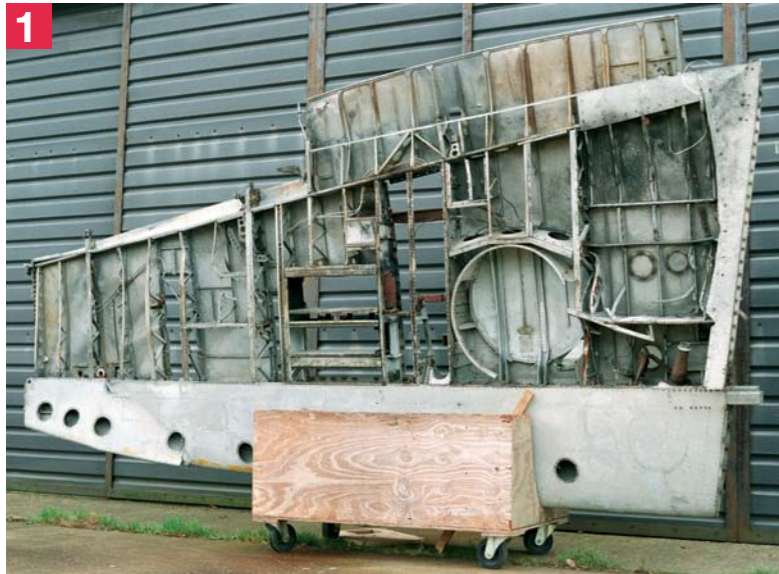
1 A port wing, stripped of most of the skinning on the underside to expose the frames and ribs, awaiting refurbishment. (Airframe Assemblies)

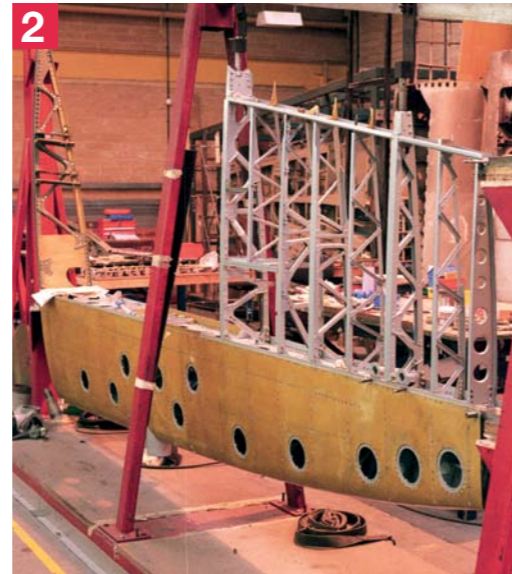
2 With the leading edge D-shaped box structure complete, the outboard frames are then attached – starboard wing shown. (Airframe Assemblies)

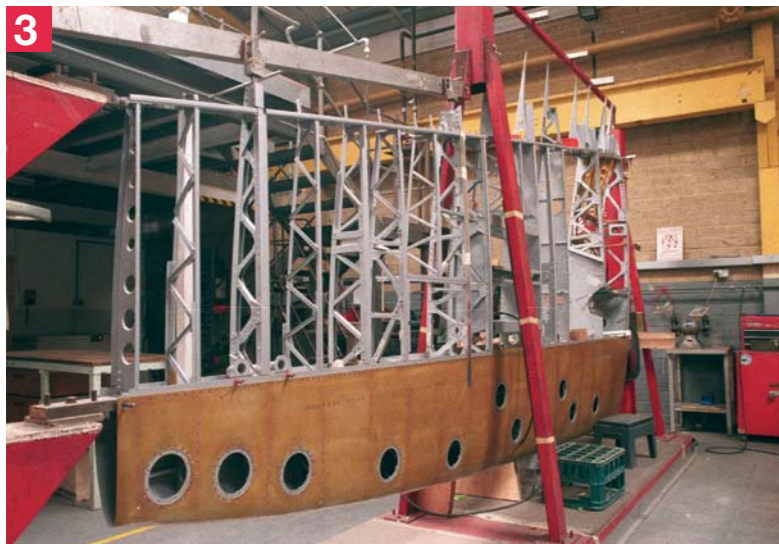
3 A view of the underside of the wing, with all the frames now in place, prior to skinning – port wing shown. (Airframe Assemblies)

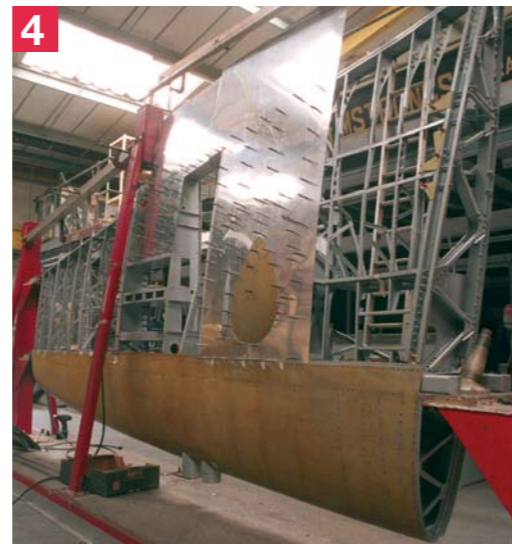
4 Here, the aluminium alloy skins are being fitted to the top surface of the wing – starboard wing shown. (Airframe Assemblies)

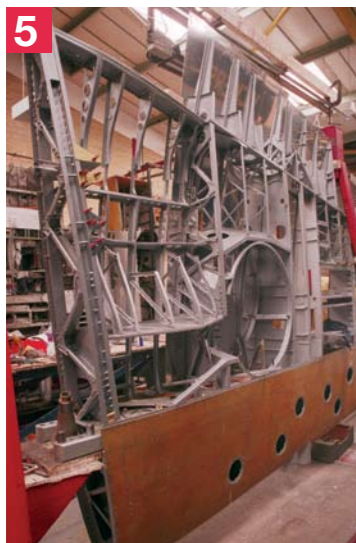
5 An underside view of the starboard wing, prior to skinning, showing the structure of the undercarriage bay. (Airframe Assemblies)

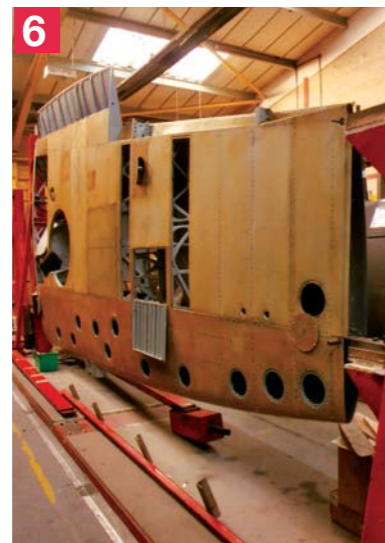
6 With the lower skins now fitted to the starboard wing, the flap shroud (top left) and the undercarriage and gun bay housings can be seen. (Airframe Assemblies)

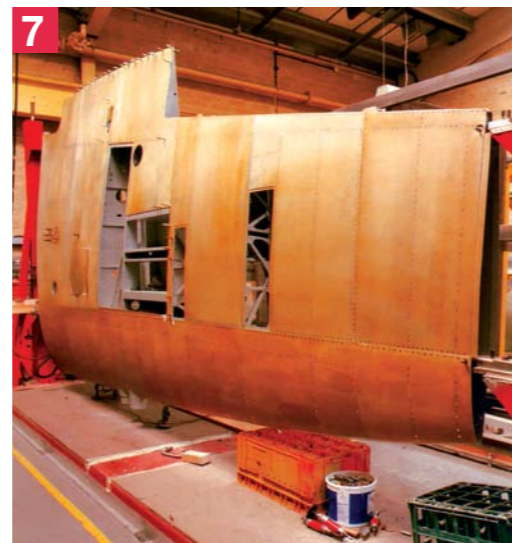
7 With the upper skins fitted to the starboard wing, the gun and ammunition bay cover panels and the aileron have yet to be fitted. (Airframe Assemblies)

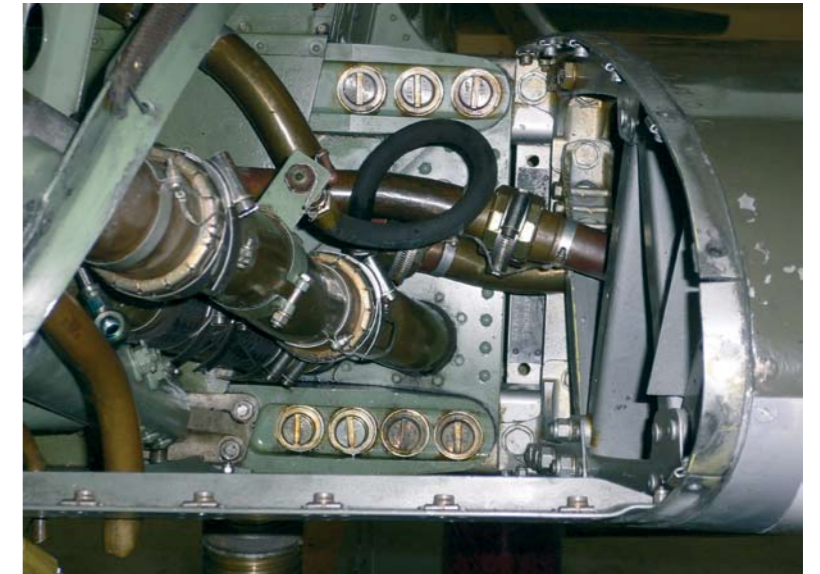
RIGHT TOP: Wing root of Mark IX MK356, showing the seven bolts, three upper and four lower, which hold the wing in place. (P. Blackah/Crown Copyright)

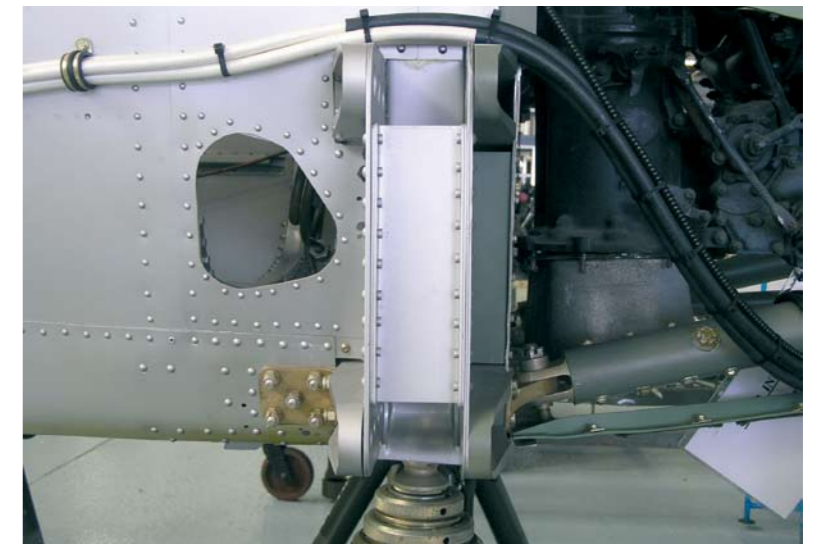
RIGHT MIDDLE: A side view of the wing stub spars attached to fuselage Frame 5, without the wings fitted. The wing spars slide into position between the stub spars and are secured by the bolts shown in the previous photograph. (P. Blackah/Crown Copyright)

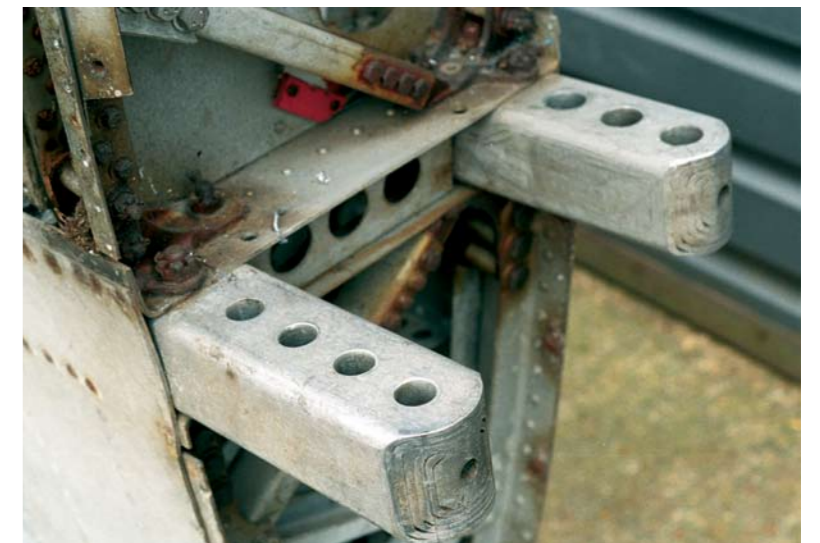
RIGHT BOTTOM: A wing awaiting restoration, showing the ends of the spar booms which attach to the stub spars on the fuselage. The bolt holes (three upper and four lower) can be seen in the spars. (P. Blackah/Crown Copyright)
